REPORT ON:
STAGE 6, LYNDHURST ROAD SUBDIVISION, FRIMLEY, HASTINGS
(LOTS 45-63)

PROJECT:
GEOTECHNICAL ASSESSMENT

CLIENT: GREENSTONE LAND DEVELOPMENTS LTD.

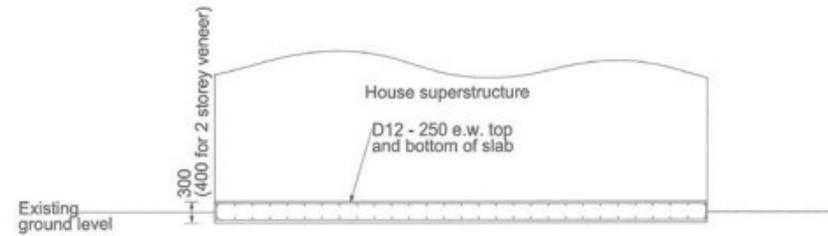
Figure 5.6: Enhanced foundation slab – Option 2

Option 2 – Construct a thick slab foundation over the existing soil.

Note: NZS ground clearances adjacent to house foundation must be complied with. DPC omitted for clarity.

Examples of appropriate foundation options and specifications are shown in figures 2 & 3.

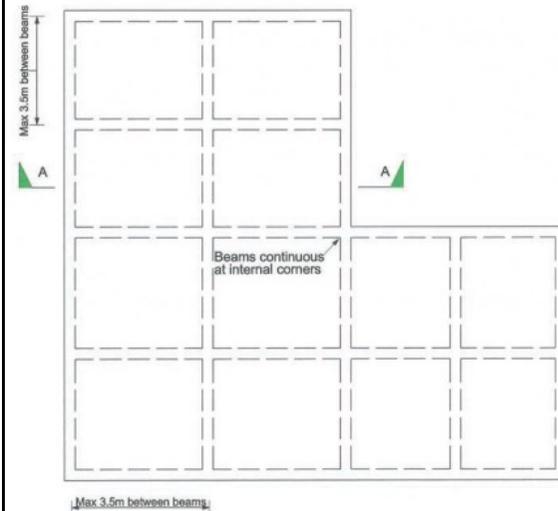
Figure 5.7: Enhanced foundation slab – Option 3 plan

Option 3 – Construct a generic beam grid and slab foundation.

Note: Reinforcing details are not sufficient for two-storey heavy-weight cladding (brick veneer) with a heavy roof but can be used for a two-storey heavy-weight cladding with a light-weight roof.

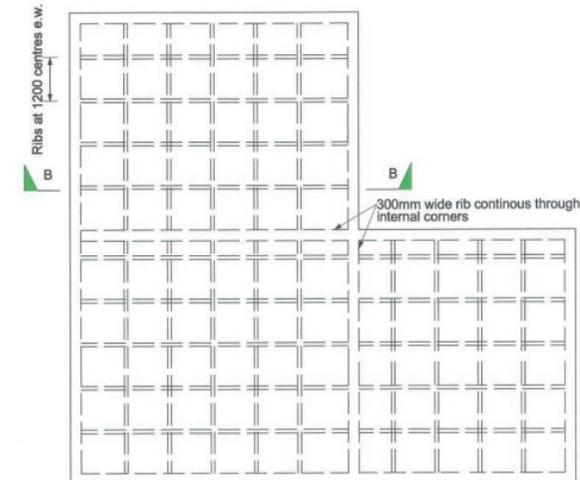
Figure 5.10: Enhanced foundation slab – Option 4 plan

Option 4 – Construct a waffle slab over the existing soil

Note: Reinforcing details are not sufficient for two-storey heavy-weight cladding (brick veneer) with either a heavy or light roof.

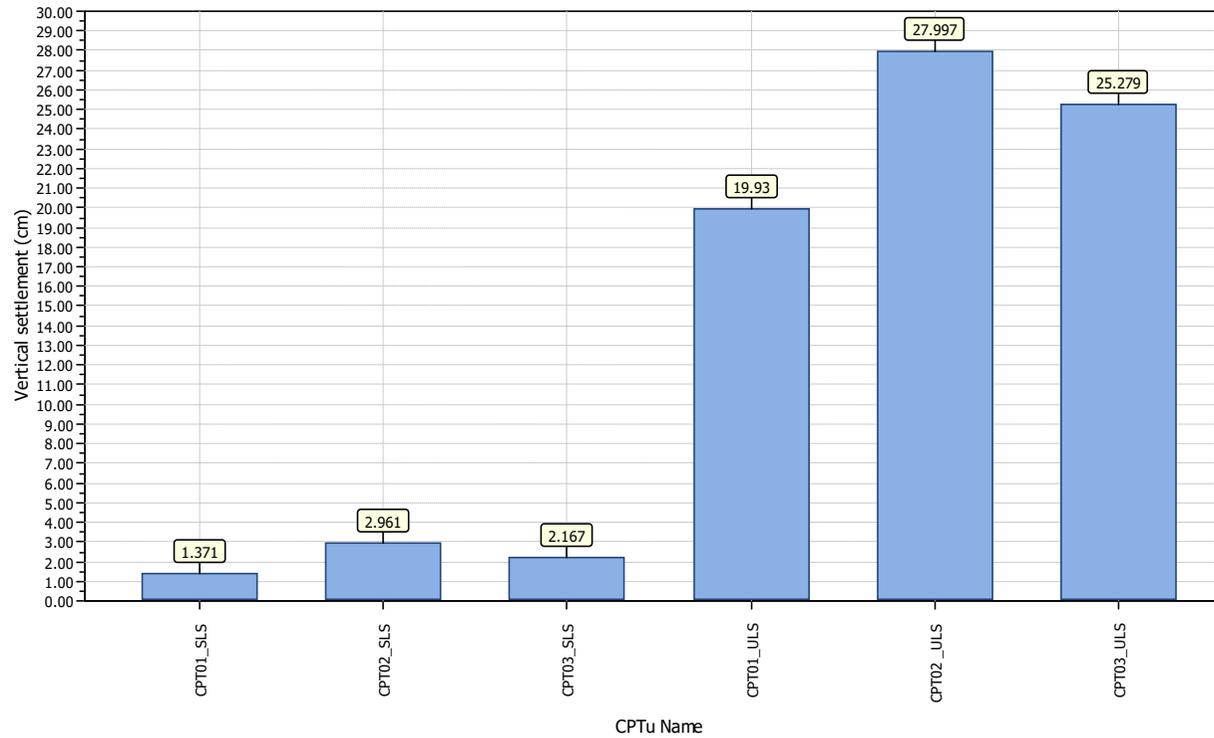
Overall vertical settlements report

- Low risk of liquefaction during a SLS earthquake event, and
- Very high risk of liquefaction during an ULS event; with
 - Expected vertical settlements on the order of 250 mm.

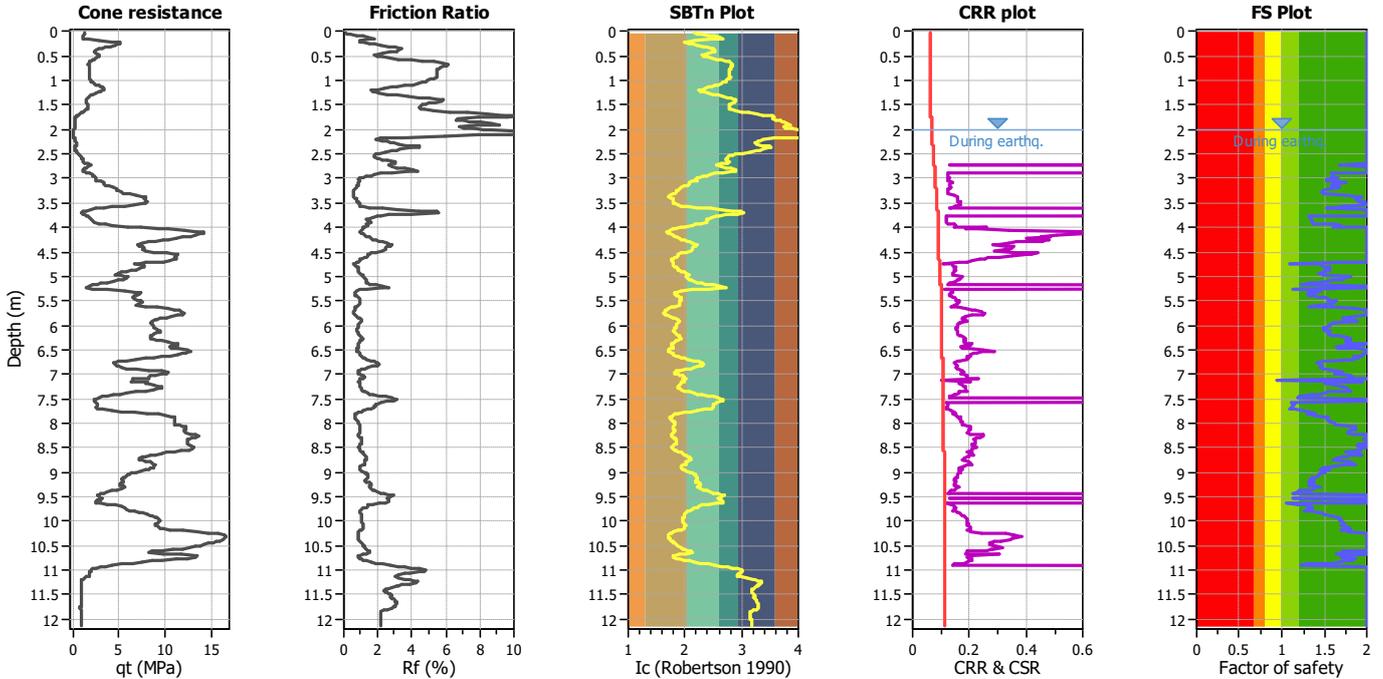
Analysis method:	B&I (2014)	G.W.T. (in-situ):	2.00 m	Use fill:	No	Clay like behavior applied:	Sands only
Fines correction method:	B&I (2014)	G.W.T. (earthq.):	2.00 m	Fill height:	N/A	Limit depth applied:	No
Points to test:	Based on Ic value	Average results interval:	3	Fill weight:	N/A	Limit depth:	N/A
Earthquake magnitude M_w :	7.50	Ic cut-off value:	2.60	Trans. detect. applied:	No	MSF method:	N/A
Peak ground acceleration:	0.11	Unit weight calculation:	Based on SBT	K_σ applied:	Yes		Method

Zone A₁: Cyclic liquefaction likely depending on size and duration of cyclic loading
 Zone A₂: Cyclic liquefaction and strength loss likely depending on loading and ground geometry
 Zone B: Liquefaction and post-earthquake strength loss unlikely, check cyclic softening
 Zone C: Cyclic liquefaction and strength loss possible depending on soil plasticity, brittleness/sensitivity, strain to peak undrained strength and ground geometry
