REPORT ON:
ARATAKI ROAD SUBDIVISION STAGE 2 AND 3

PROJECT:
GEOTECHNICAL INVESTIGATION

CLIENT:
GREENSTONE LAND DEVELOPMENTS LTD

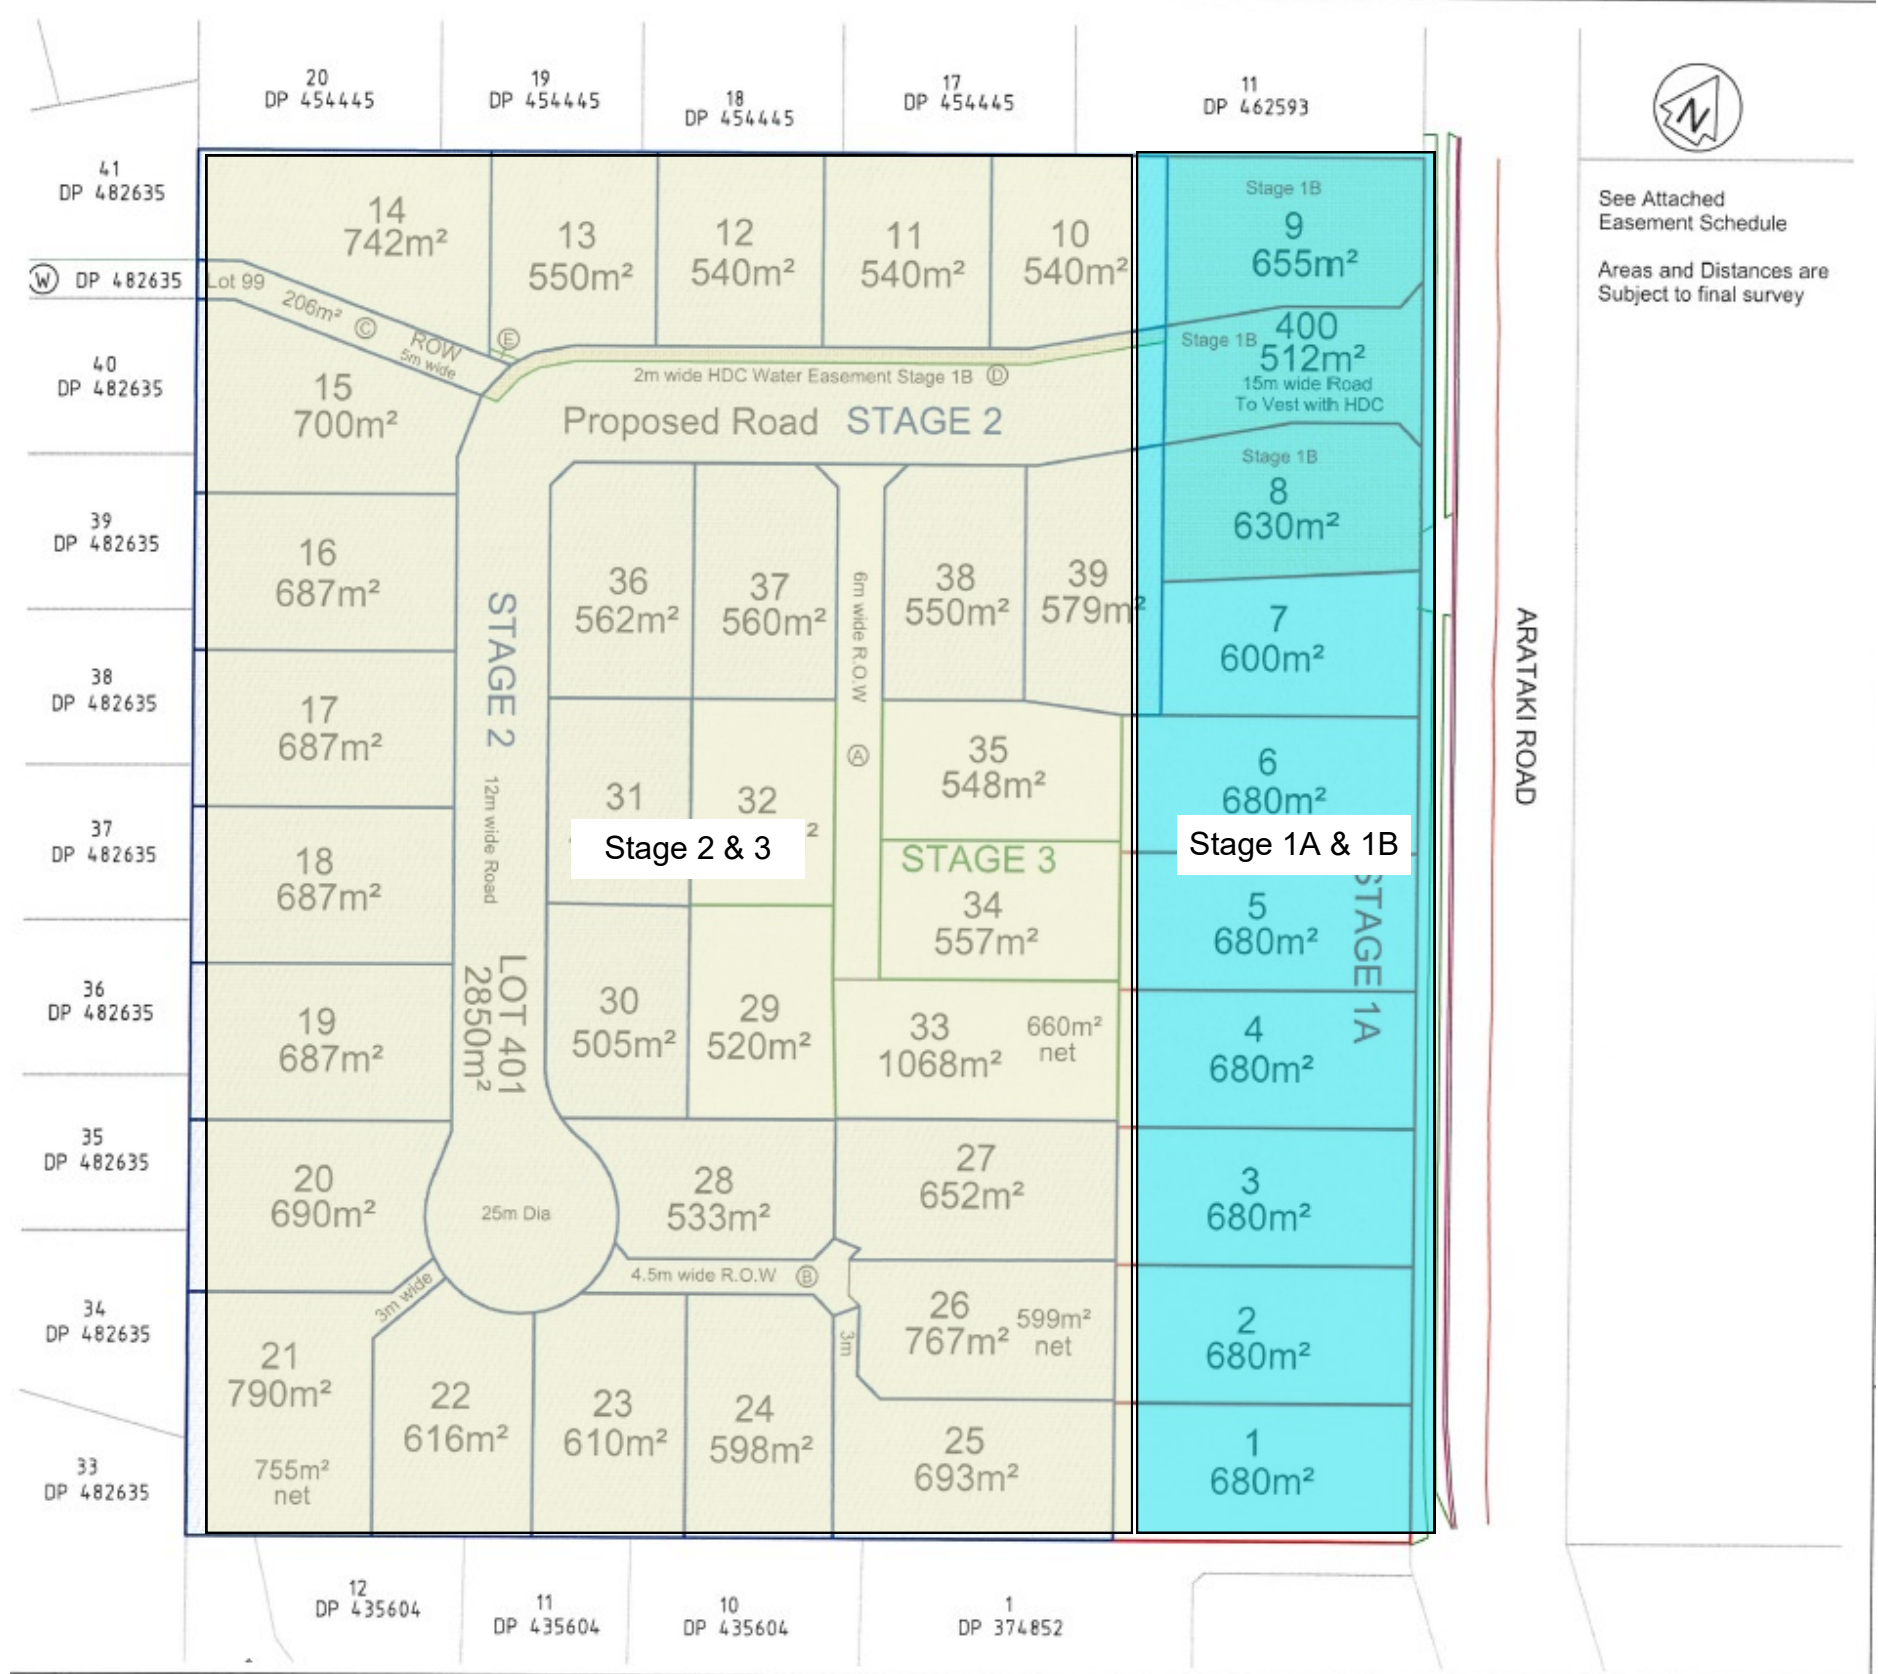
FIGURE 1 – GENERAL PLAN

Stage 2 and 3 of the development comprises thirty (30) Lots, (Lots 10 to 39) to the west of Stage 1A & B and Arataki Road (Figure 1).

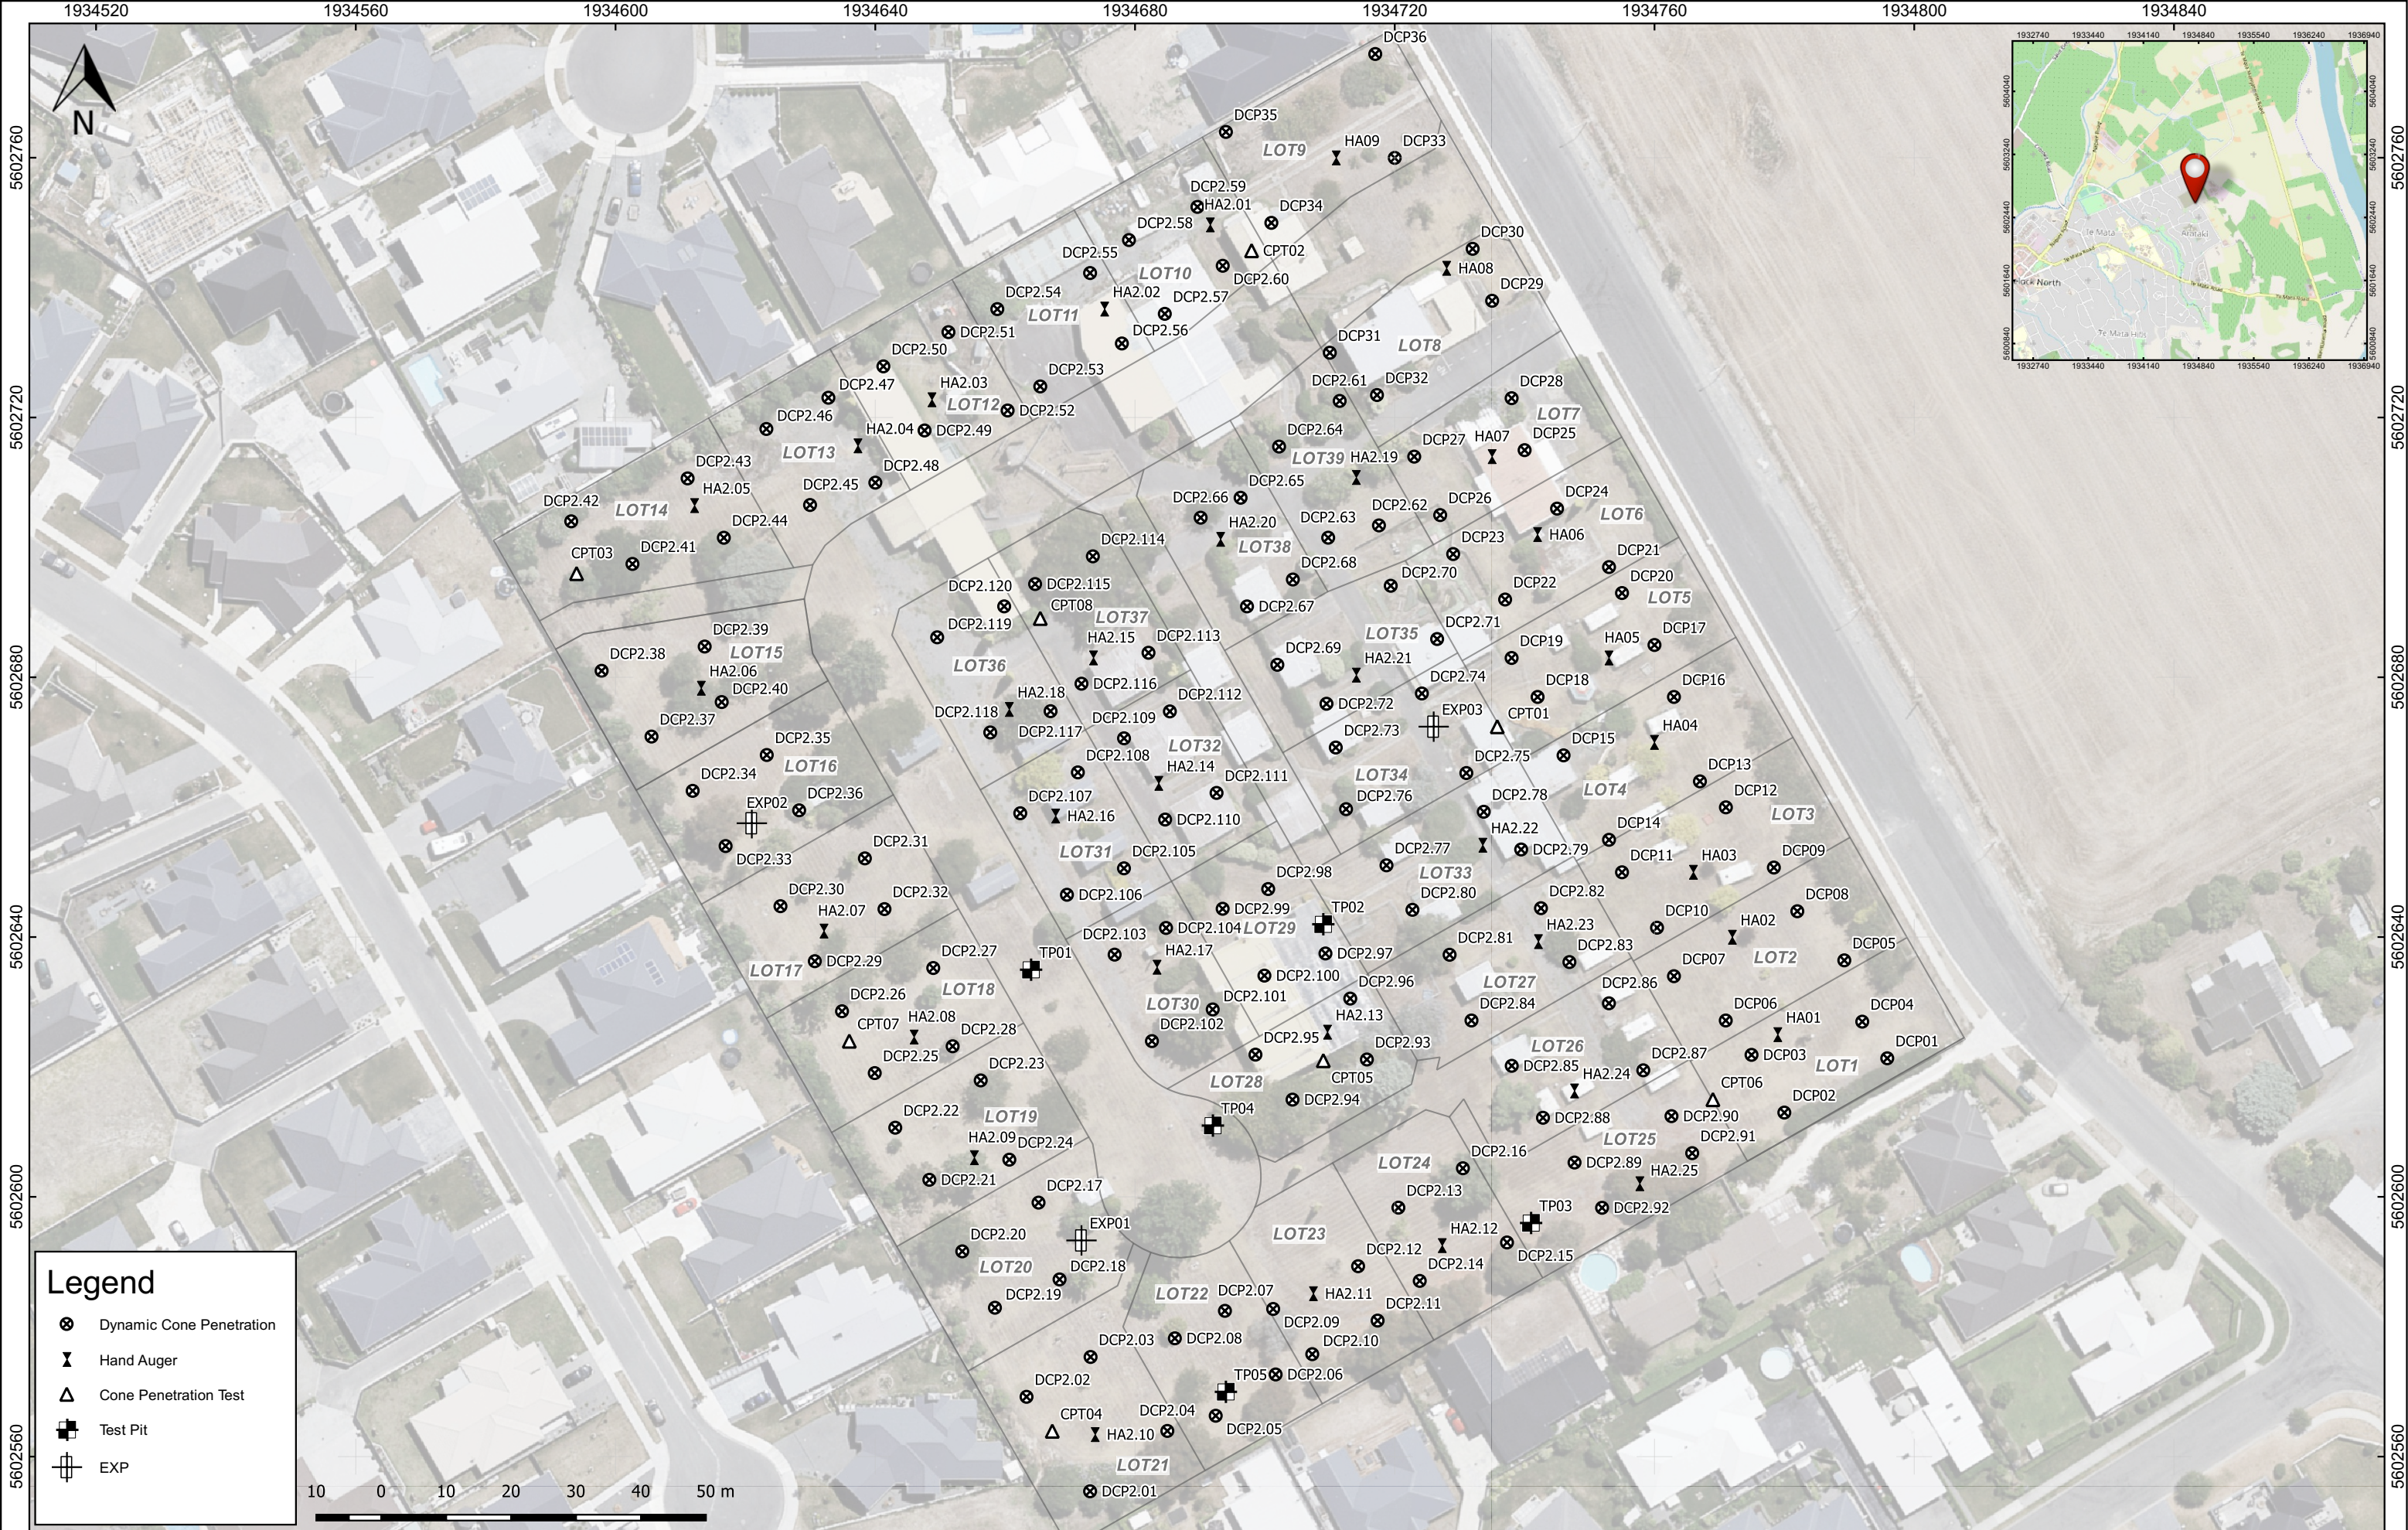
APPENDIX A – SITE INVESTIGATION PLAN

- ⊗ Dynamic Cone Penetration
- ⌵ Hand Auger
- △ Cone Penetration Test
- ⊞ Test Pit
- ⊞ EXP

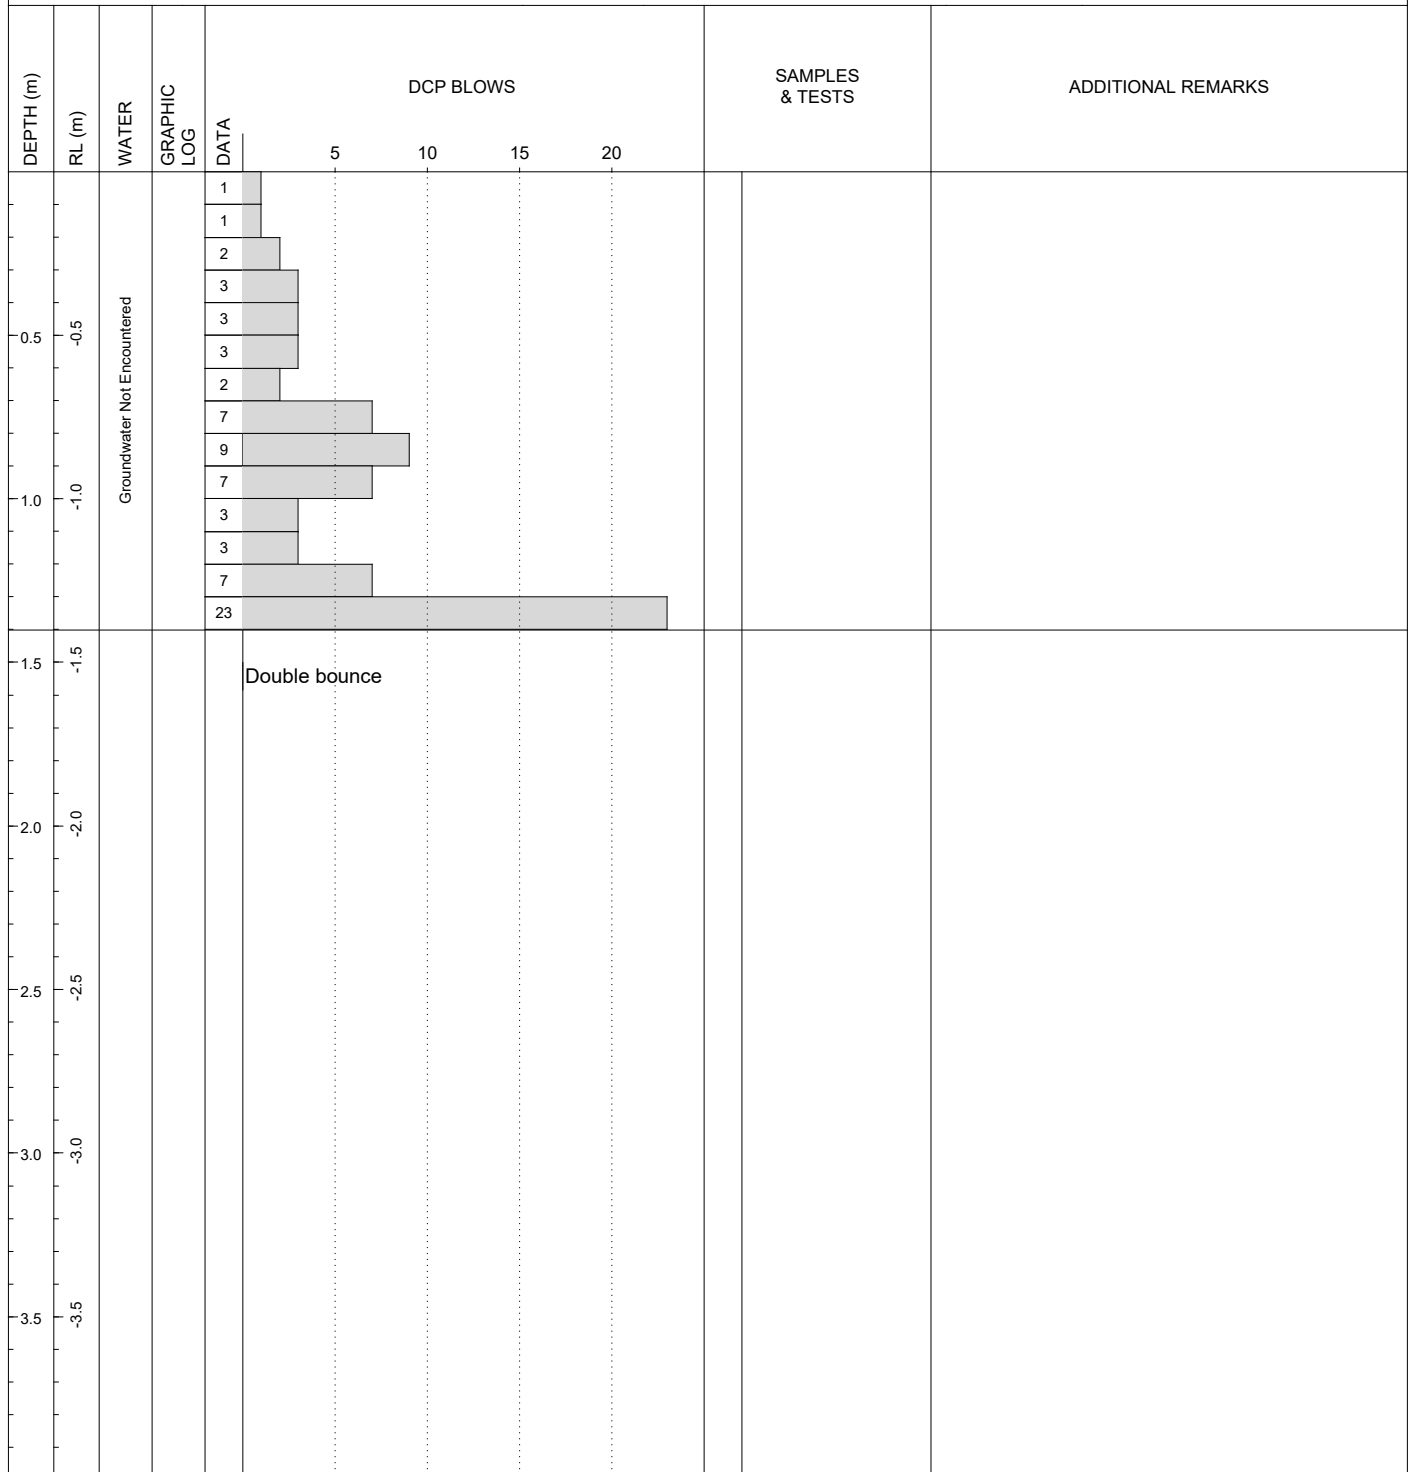
CLIENT: Greenstone Land Developments Ltd	PROJECTION: NZTM	LOCATION: Lot 10
PROJECT: 184250602	EASTING: 1934689.61	STARTED: 17-01-2019
LOCATION: 139 Arataki Road	NORTHING: 5602752.46	FINISHED: 17-01-2019
OFFICE: RDCL - Hastings	DATUM:	LOGGED BY: MD/BR DATE: 17-01-2019
ENGINEER: TB	ELEVATION: -	CHECKED BY: SD DATE: 18-01-2019
	AZUMITH: 0° PLUNGE: 90°	STATUS: Final data
