KENNY ROAD SUBDIVISION DEVELOPMENT,  
TE AWA, NAPIER

GEOTECHNICAL INVESTIGATION AND  
COMPLETION REPORT FOR LOTS 2 TO 24

INITIA REF P-000821 REV A

NOVEMBER 2020

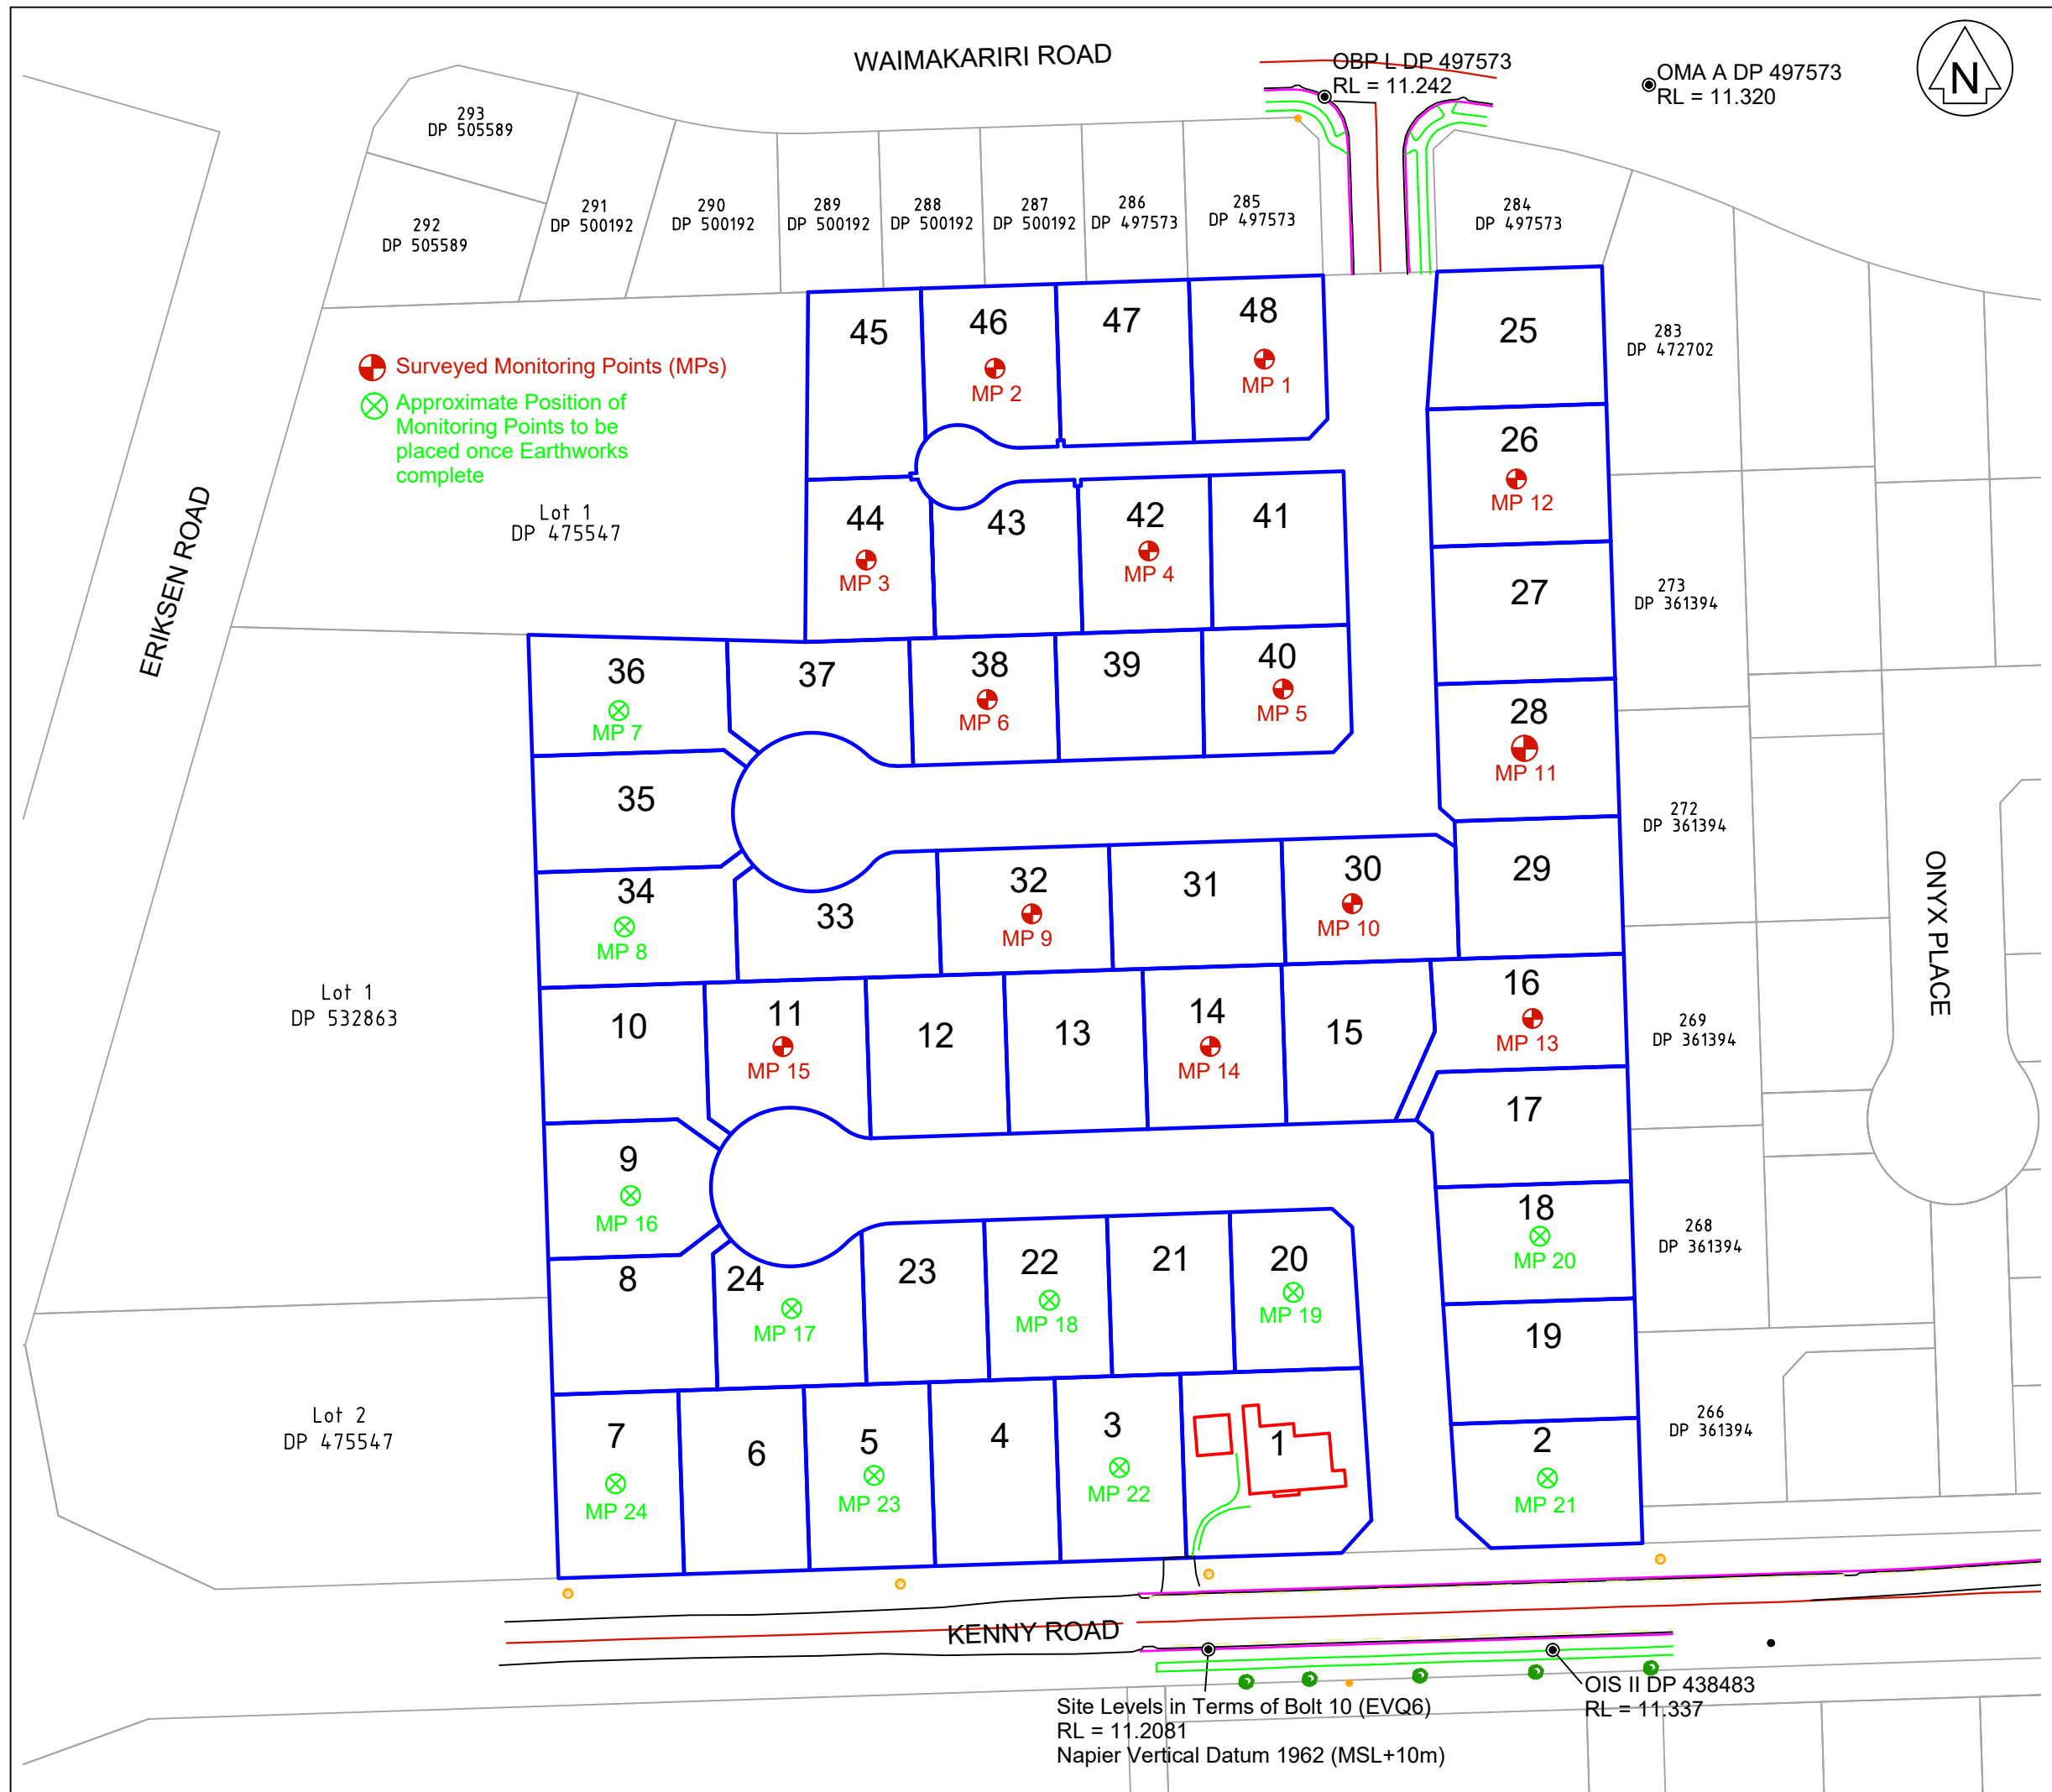
DATE : 25/06/2020  
SCALE : 1:1000 @ A3  
DRAWN BY : R.Mac  
JOB NO. : J001387  
PLAN NO. : MP250620

C/O GLDL  
KENNY ROAD SITE  
TE AWA, NAPIER  
SETTLEMENT MONITORING  
POINTS LOCATION DIAGRAM
