GREENSTONE LAND DEVELOPMENTS LTD

KENNY ROAD SUBDIVISION DEVELOPMENT,
TE AWA, NAPIER

GEOTECHNICAL INVESTIGATION AND
COMPLETION REPORT FOR LOTS 25-48

INITIA REF P-000821 REV A

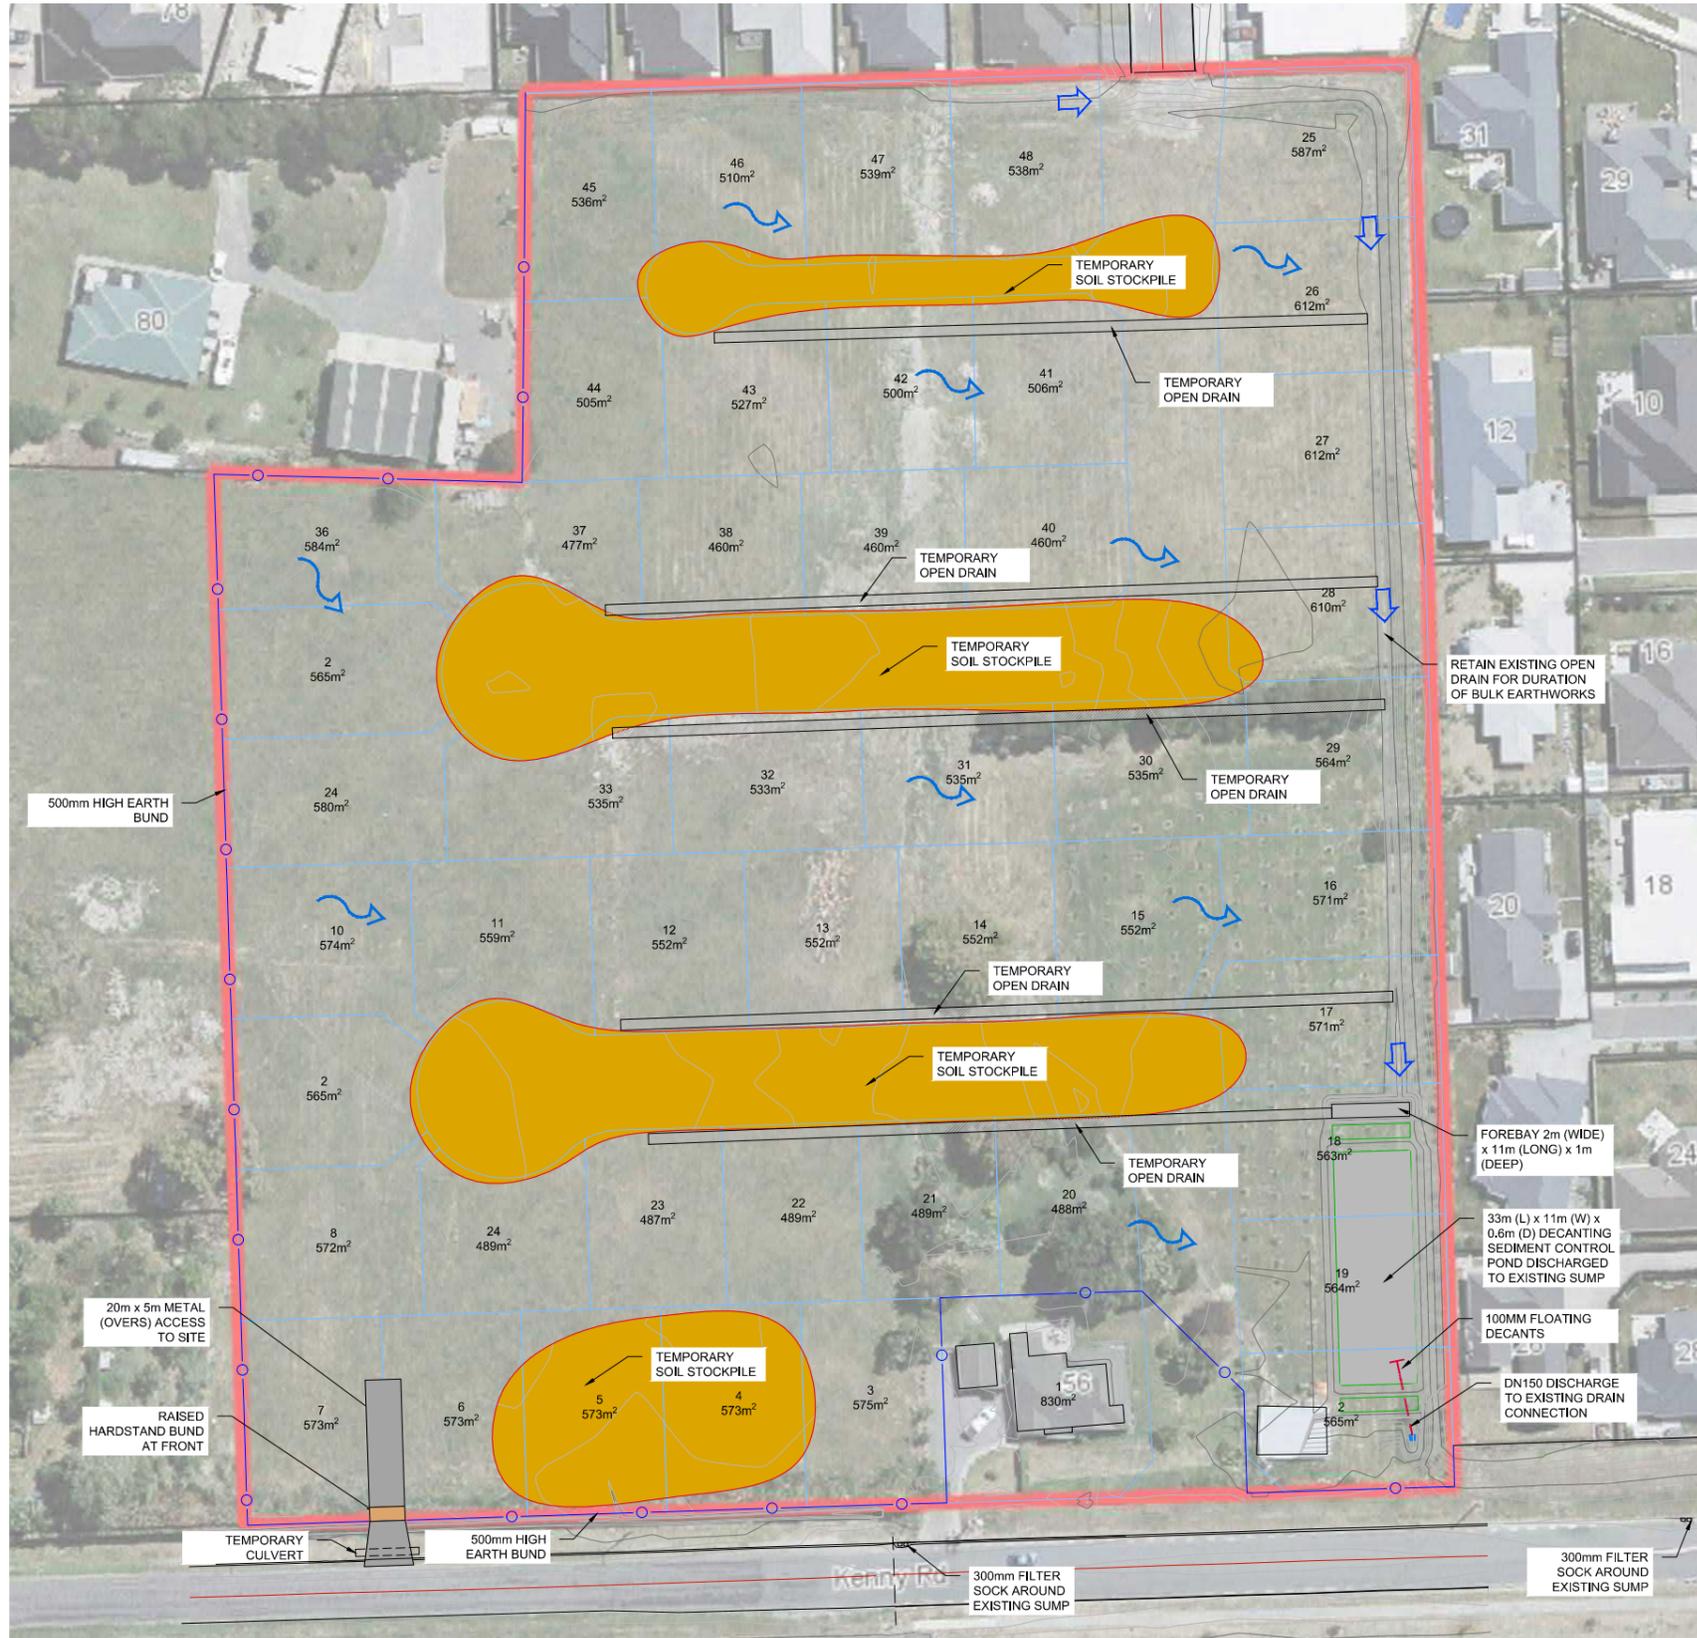
- EROSION & SEDIMENT CONTROL NOTES:**
- ALL EROSION AND SEDIMENT CONTROL MEASURES SHALL BE IN ACCORDANCE WITH "HAWKES BAY REGIONAL COUNCIL - HAWKES BAY WATERWAY GUIDELINES EROSION AND SEDIMENT CONTROL".

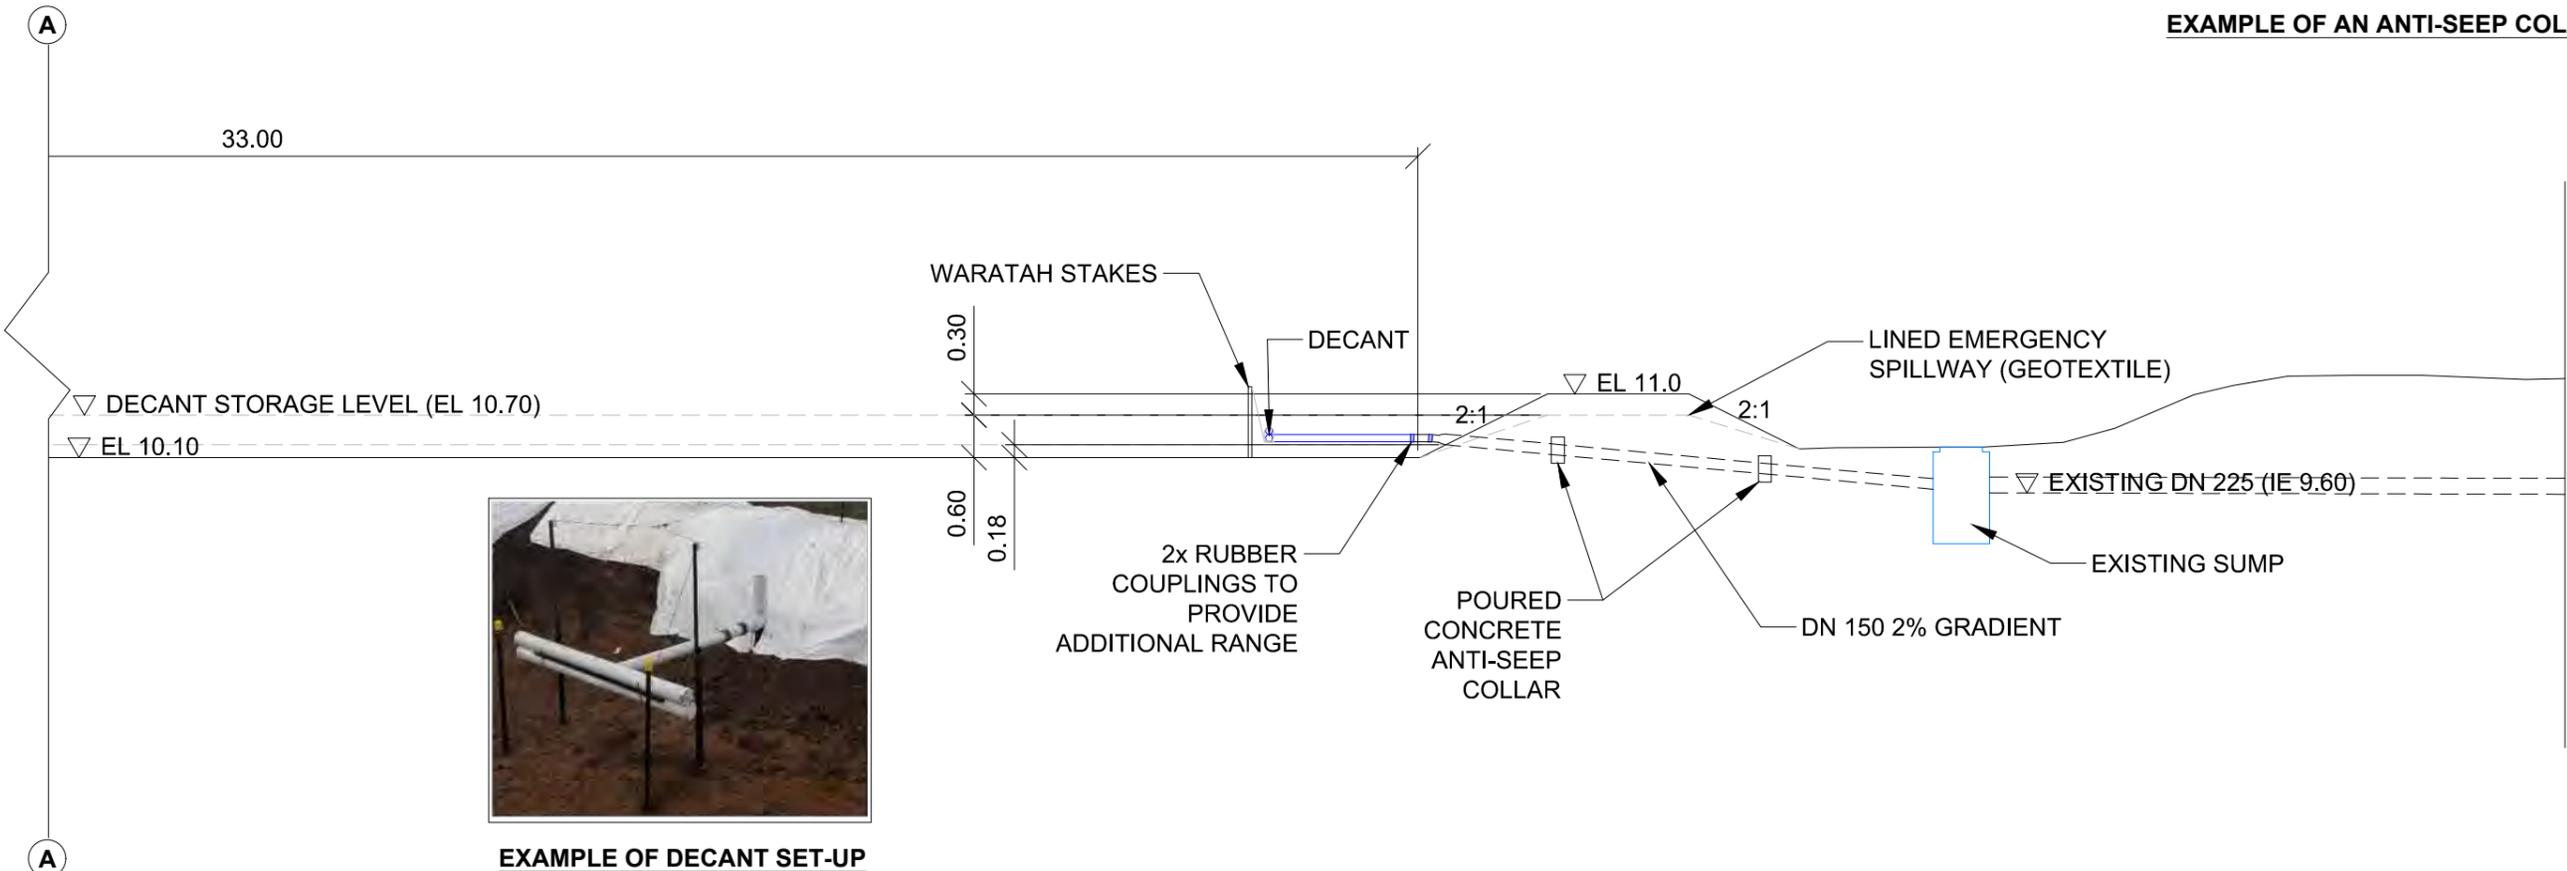
EXAMPLE OF DECANT SET-UP

POND LONG SECTION

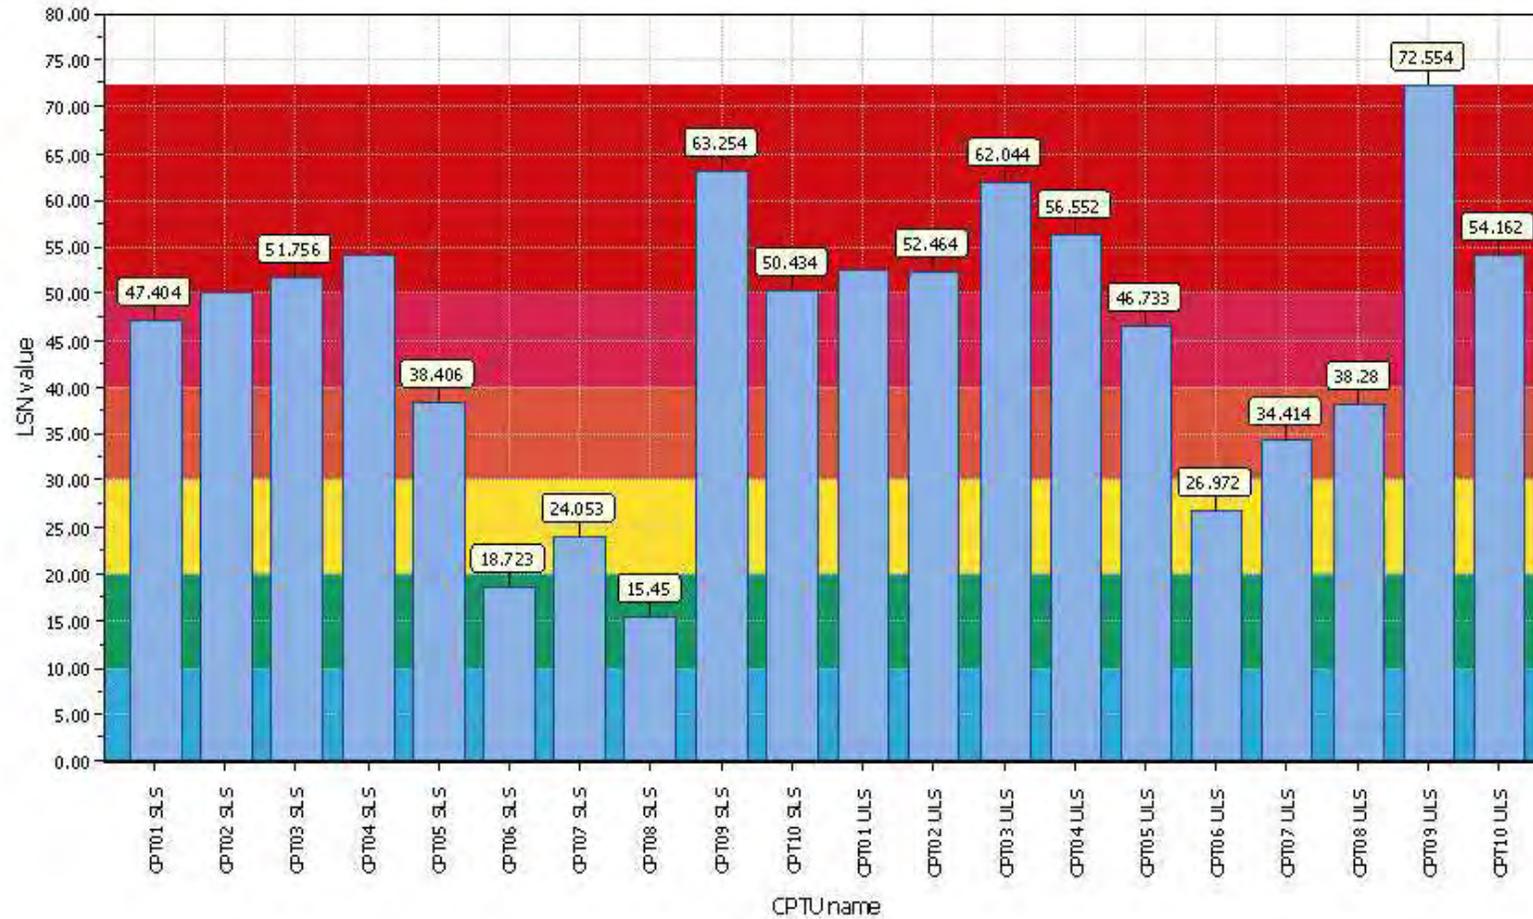
Overall Liquefaction Severity Number report

LSN color scheme

Unit ID	Material Description	Identified potentially liquefiable zone			LSN	LPI
		Depth from (m)	Depth to (m)	Thickness (m)		
Unit 3	Firm sandy SILT and SAND	1.2-1.6	1.3-2.5	0.1-0.7	15-30	12-25
Unit 5	Loose Silty SAND and SAND interbedded with SILT and CLAY	3.0	10-11.8	0.1-2.5

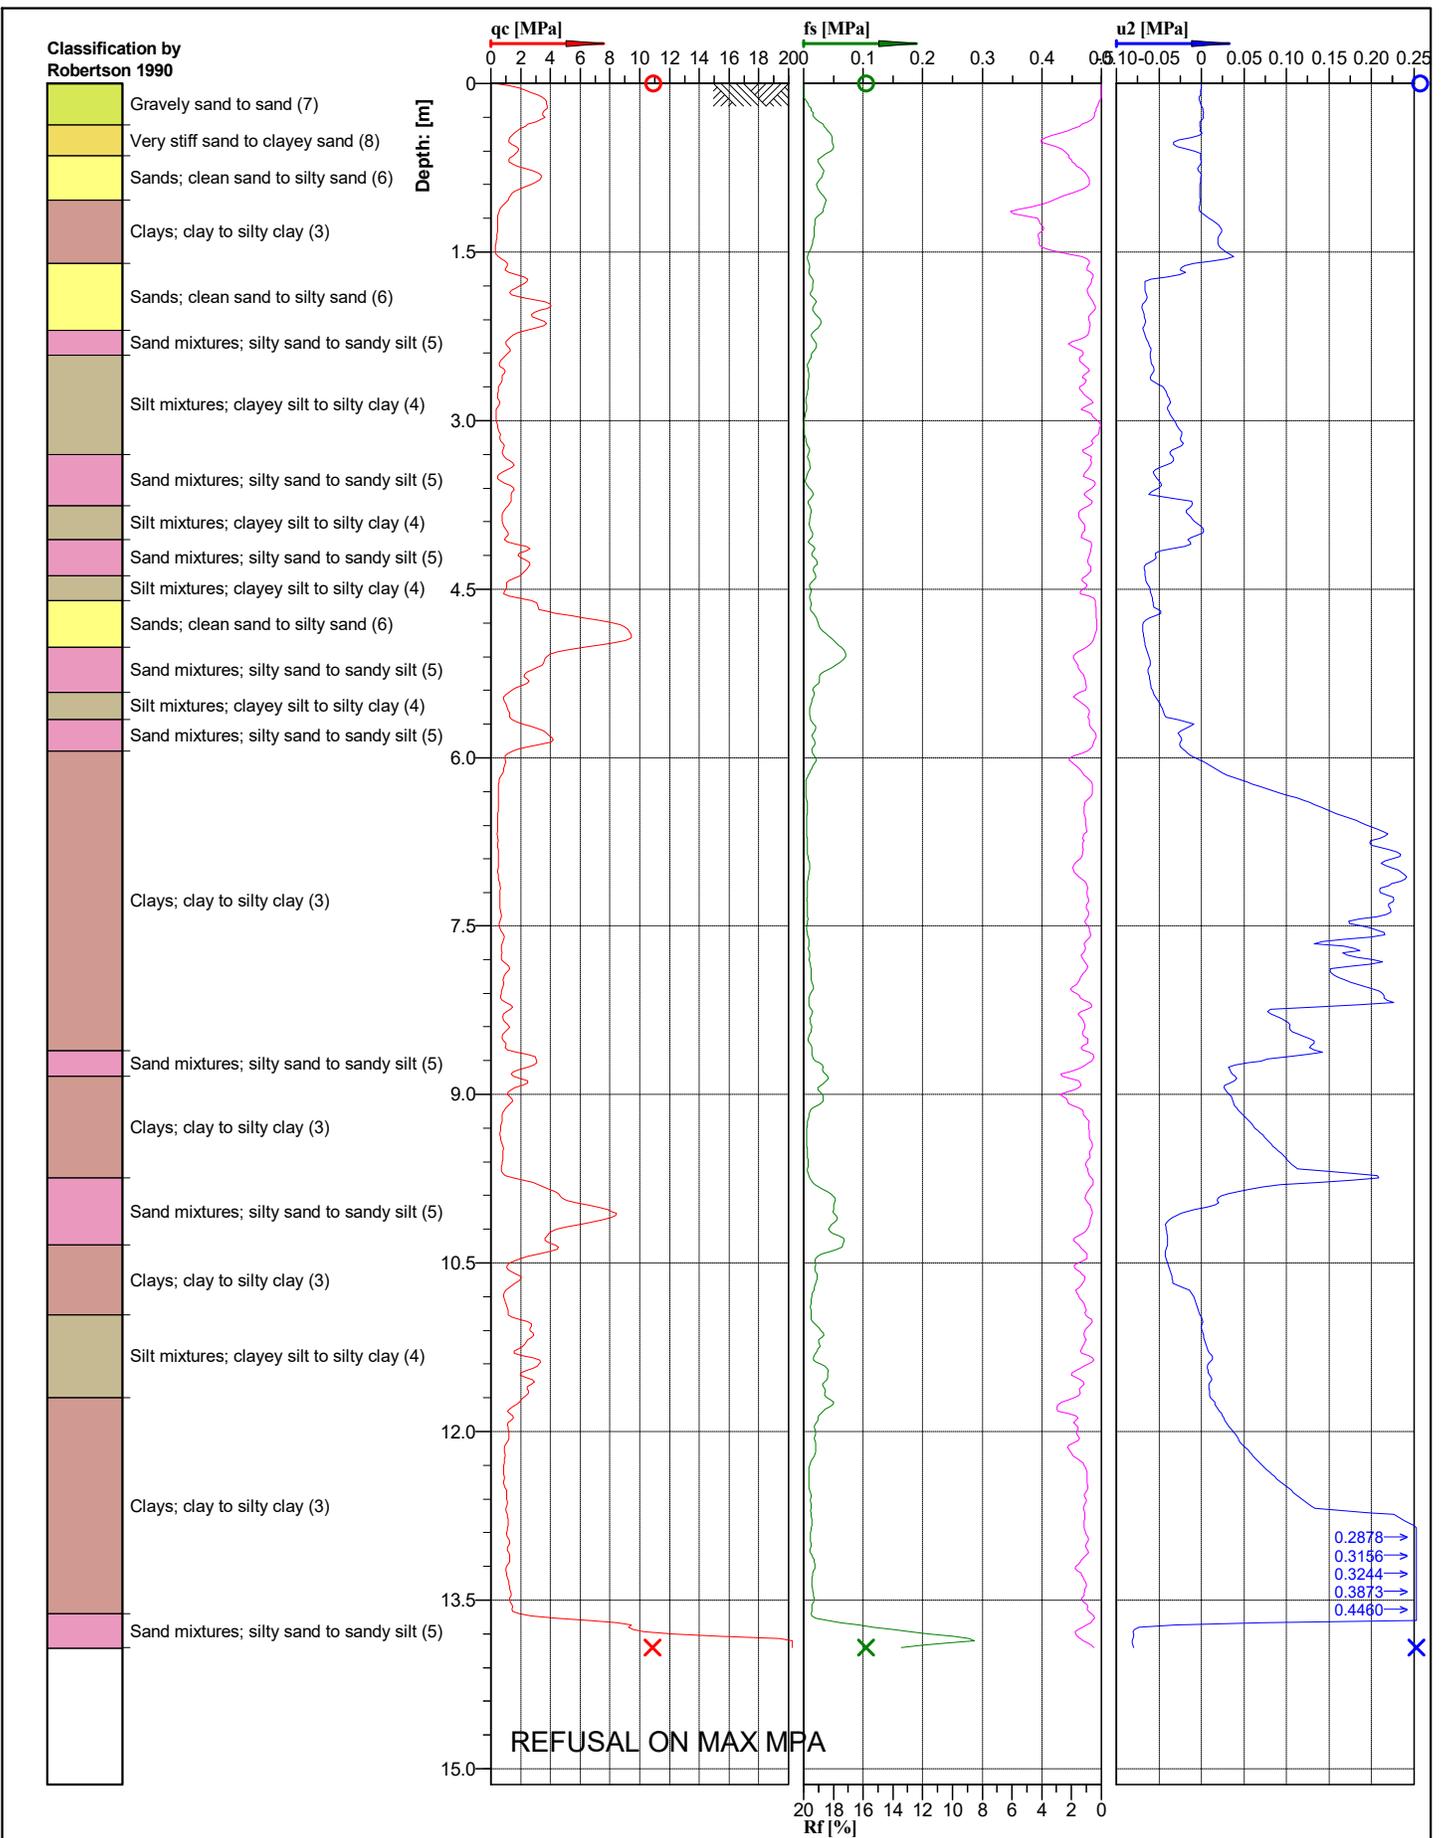
Location: NAPIER	Position: X: 0.00 m, Y: 0.00 m	Ground level: 0.00	Test No.: CPT22
Project ID:	Client: INITIA	Date: 22/05/2020	Scale: 1 : 67
Project: TE AWA KENNY RD		Page: 1/1	Fig.:
S 39.52594 E 176.91226			File: CPT22.cpt

Cone No: 5447
 Tip area [cm²]: 10
 Sleeve area [cm²]: 150

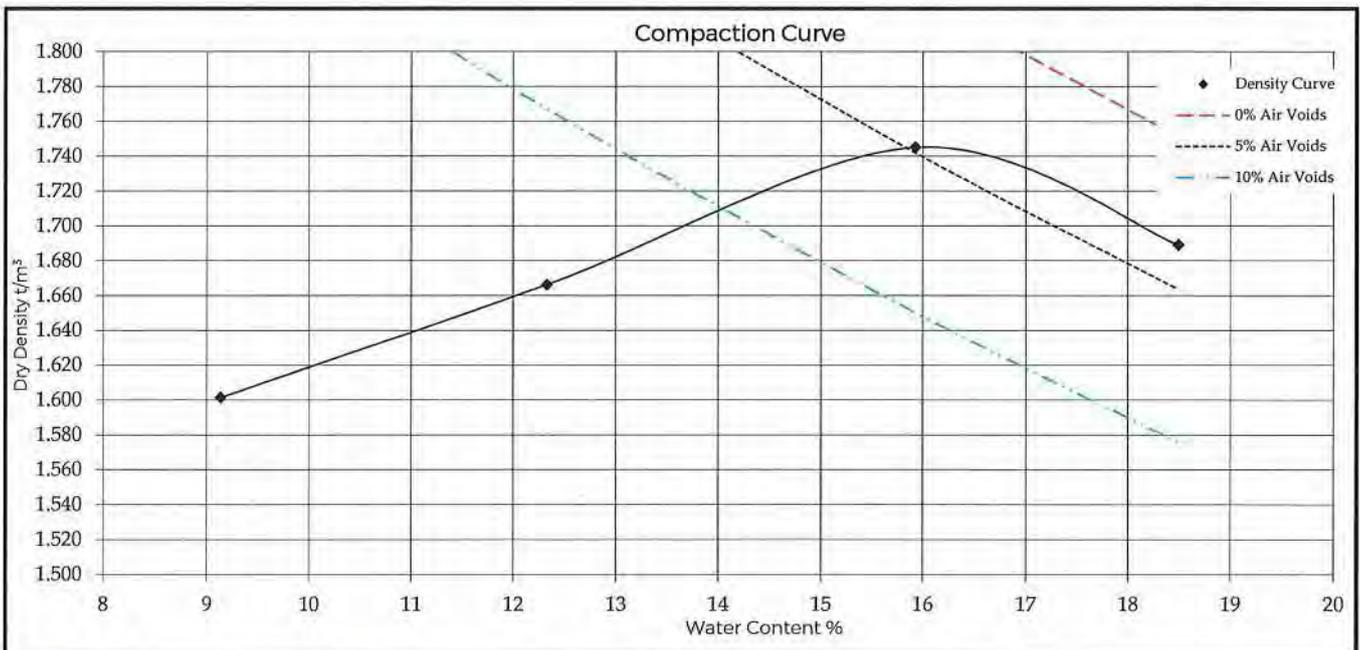
Test Results							
Maximum dry density	1.74	t/m ³	Natural water content	12.3	%		
Optimum water content	15.9	%	Fraction tested	Passing 19mm test sieve			
Sample ID	2	Nat	3	4			
Bulk density t/m ³	1.748	1.872	2.023	2.002			
Water content %	9.1	12.3	15.9	18.5			
Dry density t/m ³	1.601	1.666	1.745	1.689			
Sample condition	Dry Firm	Dry Firm	Moist Stiff	Wet Soft

Test Methods	Notes
Compaction NZS 4402 : 1986 Test 4.1.1 (Standard)

Some high voids have been noted on the test data received by Initia. We understand that this was due to a delay in the earthworks testing following compaction in warmer summer months.

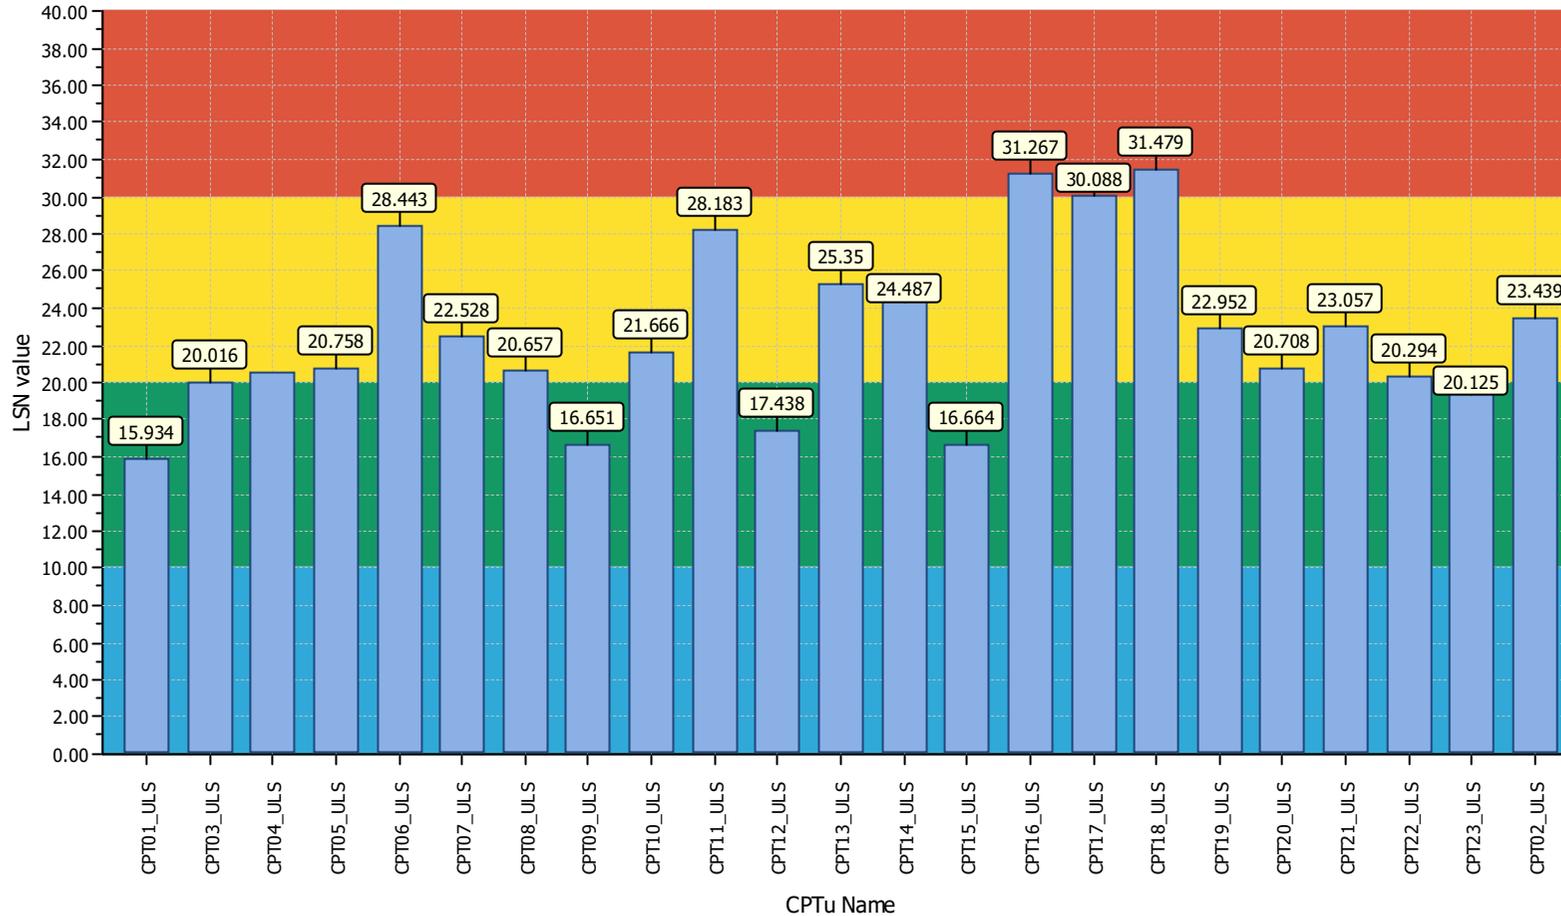
Overall Liquefaction Severity Number report

LSN color scheme

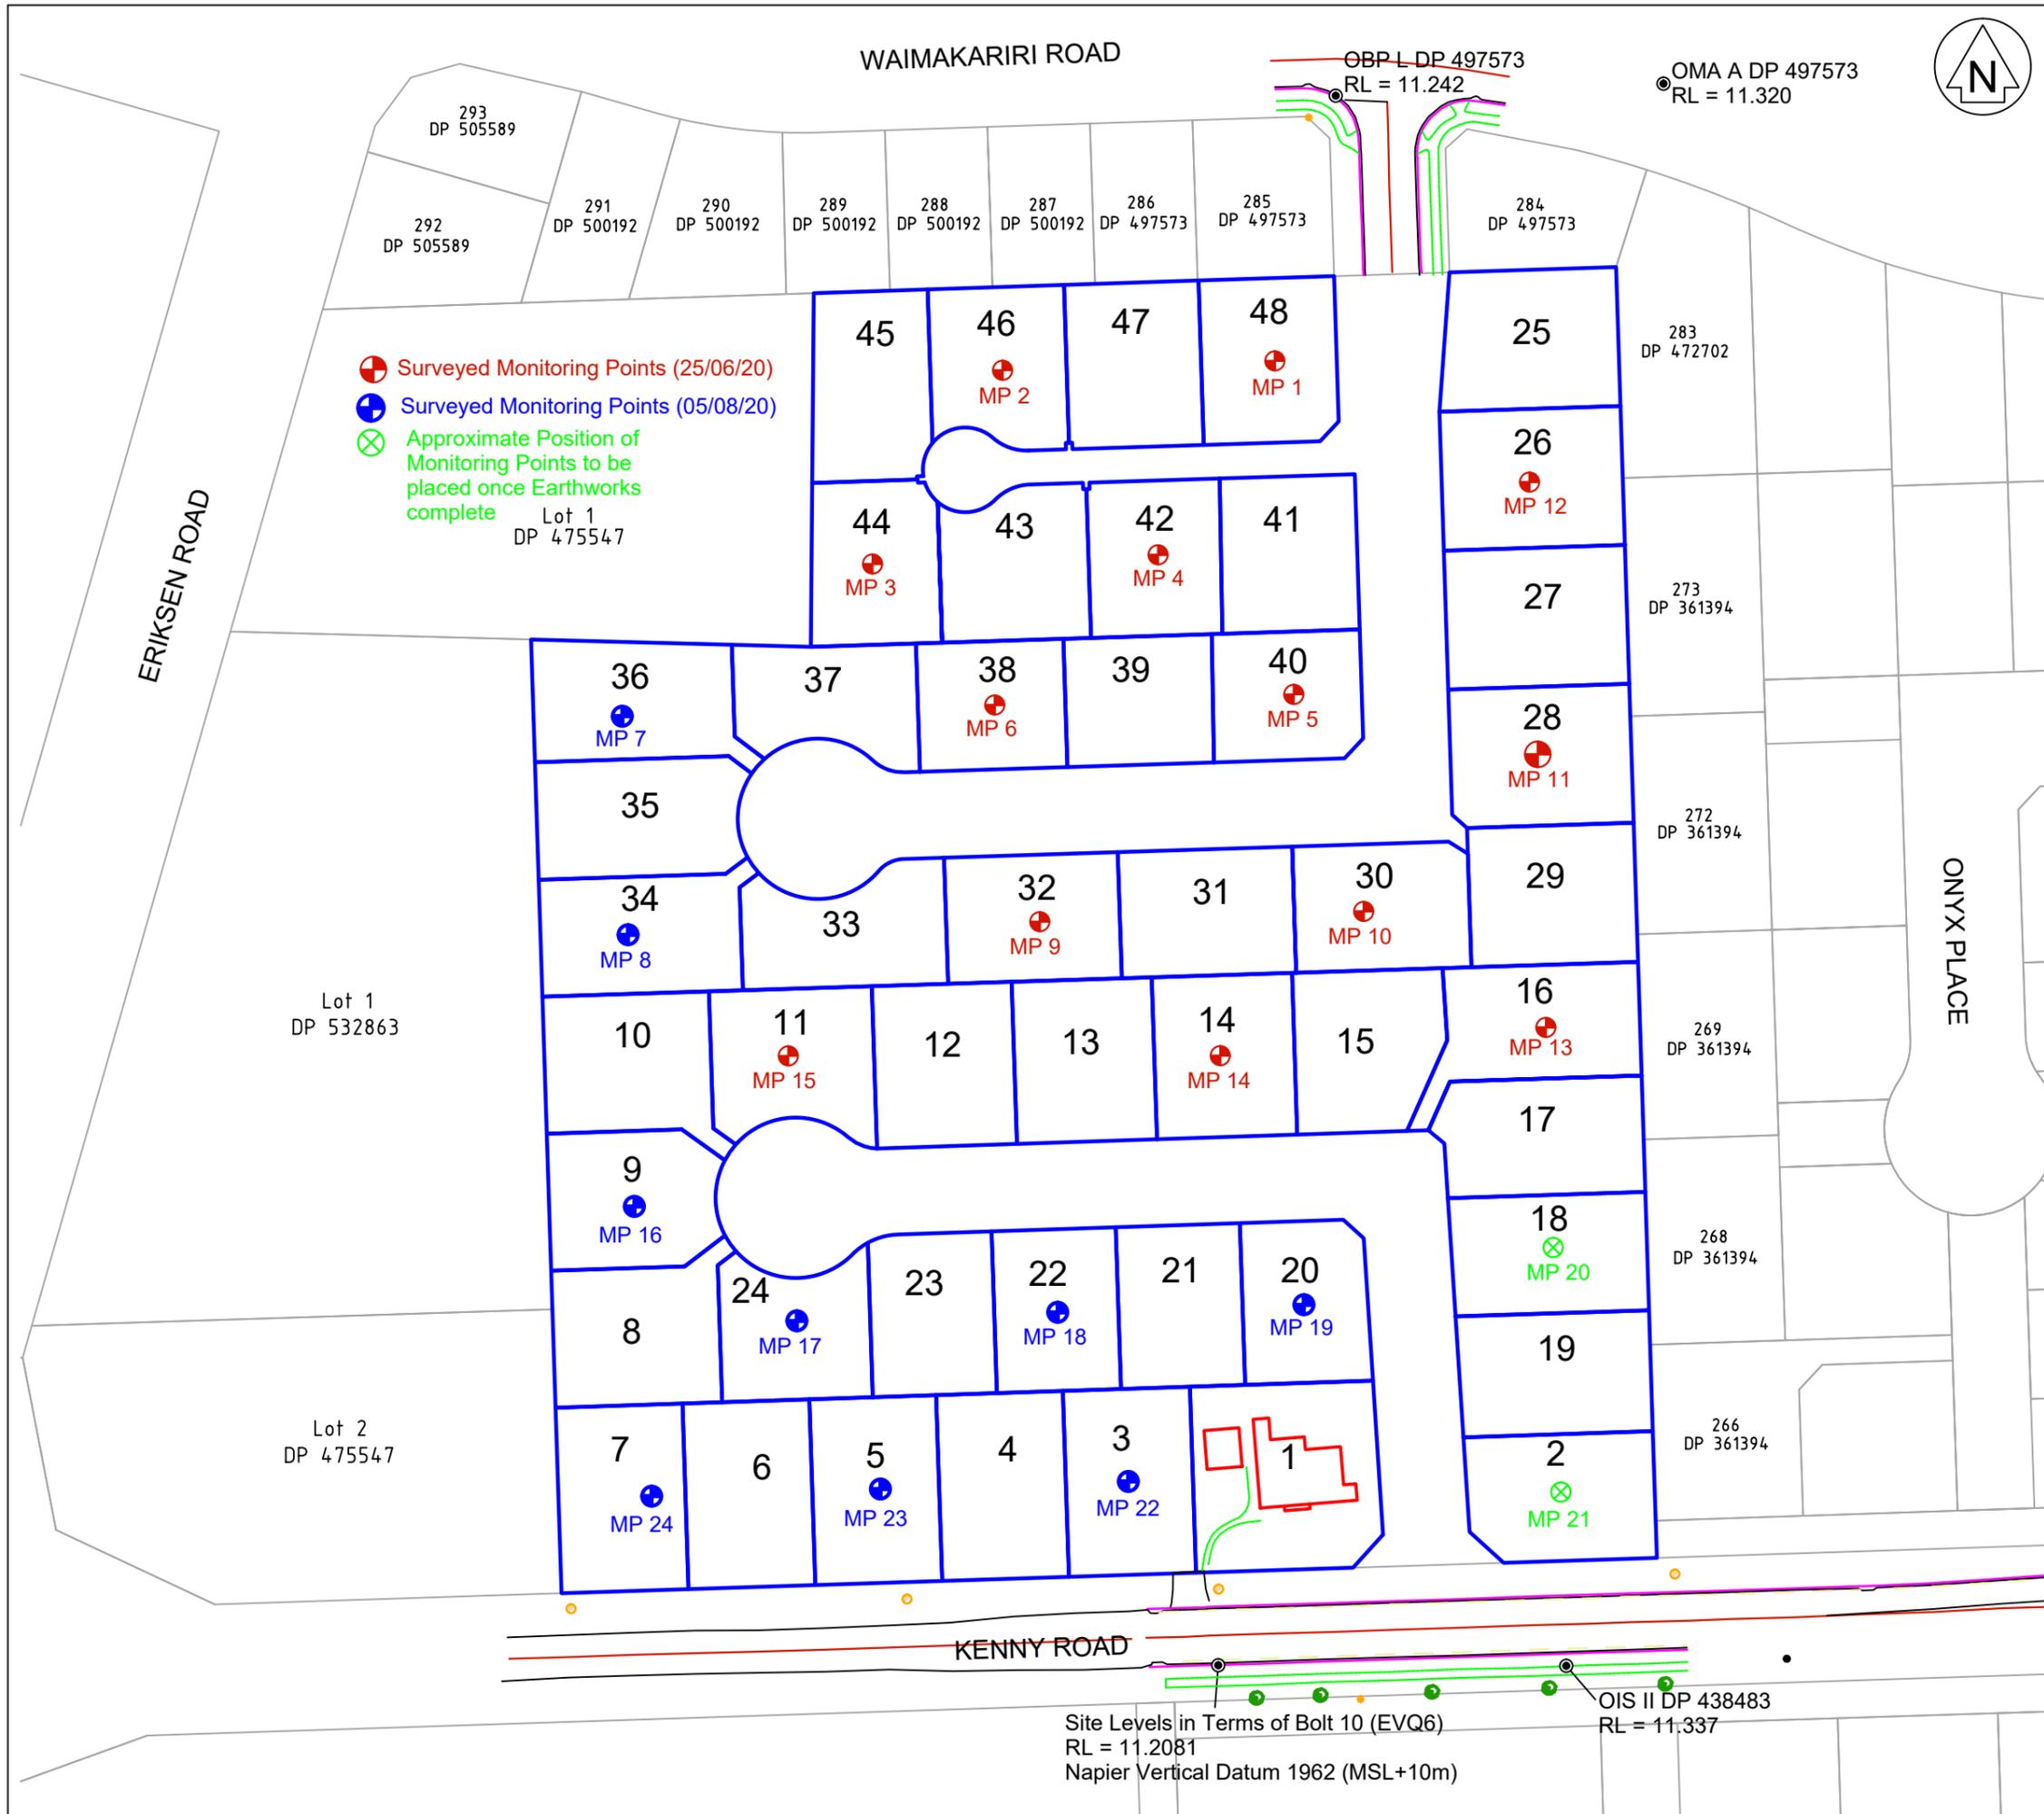
C/O GLDL
KENNY ROAD SITE
TE AWA, NAPIER
SETTLEMENT MONITORING
POINTS LOCATION DIAGRAM
